Walk Audit Summary

Walk audits along segments of the Sustainable Transportation Plan (STP) priority corridors were conducted over the course of two days in June 2022 by engineering and planning staff from the Oxnard Public Works Department and Fehr & Peers on the STP project team. Members of the STP Advisory Committee and Focus Group were invited to participate, and representatives from the Mixteco Indigena Community Organizing Project (MICOP) and the Central Coast Alliance United for a Sustainable Economy (CAUSE) joined the walk audit. The purpose of the walk audits was to evaluate the existing conditions of the priority corridors and inform recommendations that encourage and improve multimodal transportation in Oxnard as part of the City of Oxnard's *Sustainable Transportation Plan*.

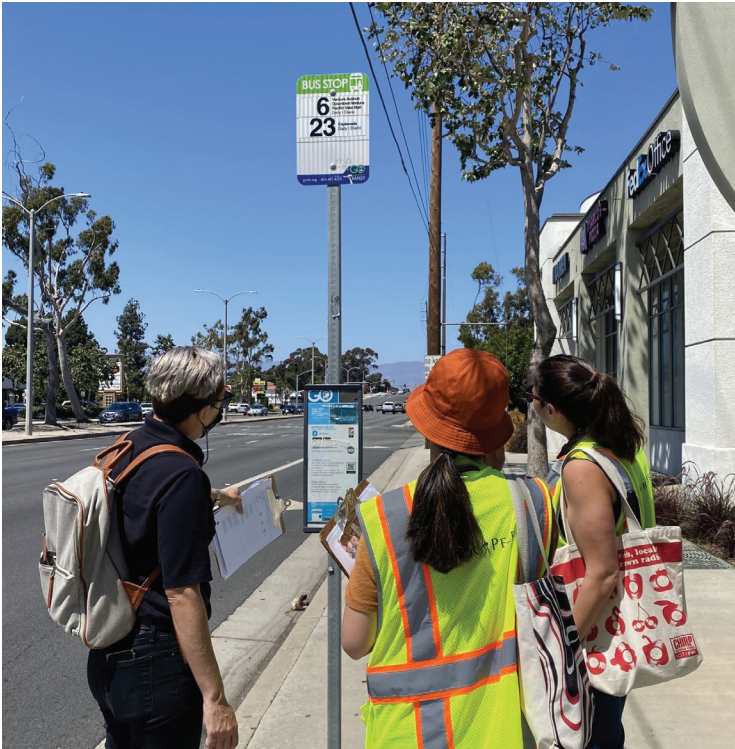
Discussion around opportunities to improve transit information, such as real-time information and bilingual information.

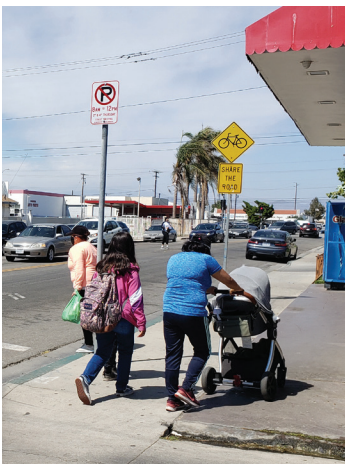
Families walking in neighborhood, particularly around commercial areas.

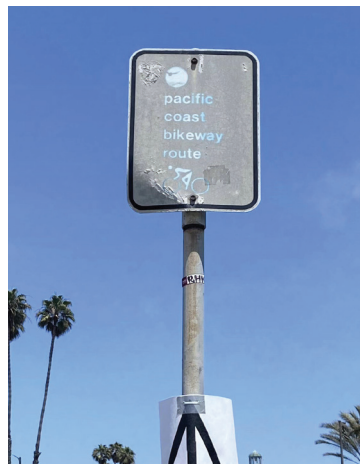
Signage near Channel Islands Boulevard & Victoria Avenue illustrates a long history of biking and an opportunity to modernize wayfinding and signage.

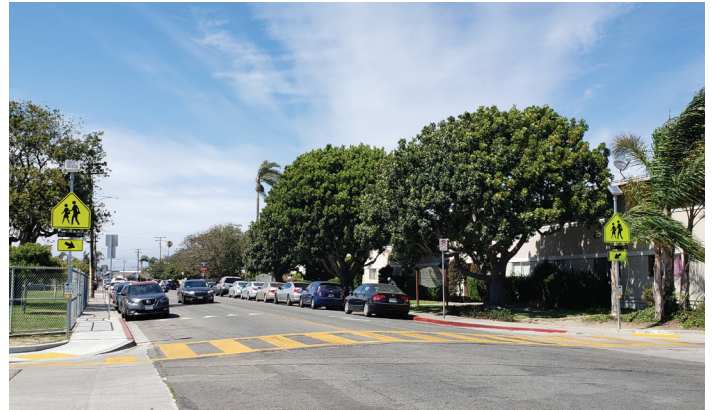
Observed high-visibility crosswalks and flashing beacons near key school entrances to enhance pedestrian visibility around schools.

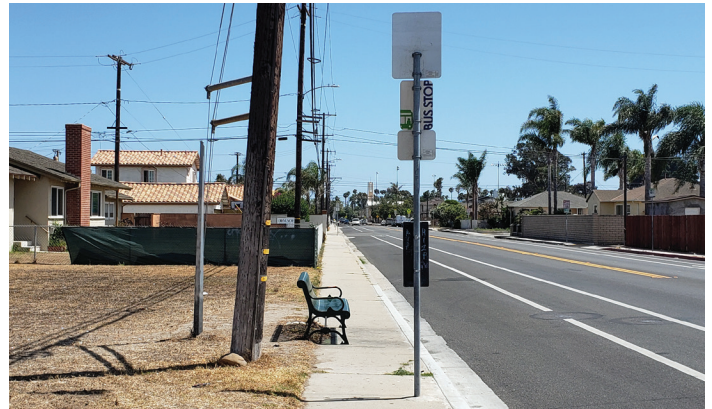
Many bus stops would benefit from bus shelters.

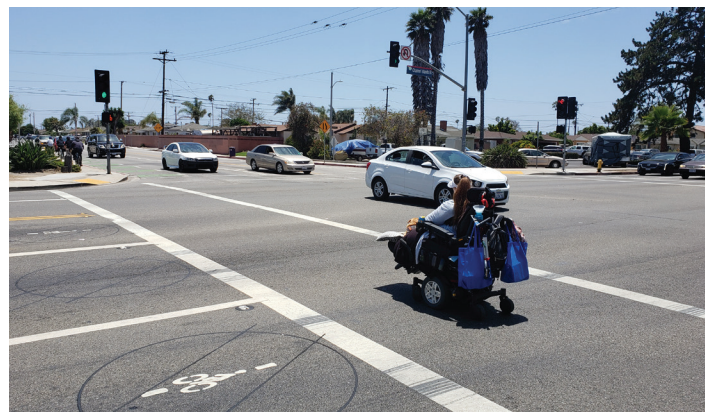
Observed people crossing near Centerpoint Mall who may need more crossing time.

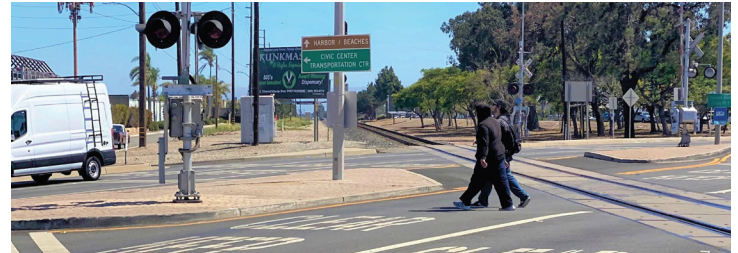
Observed people walking and biking using the medians around the railroad to cross the Vineyard Boulevard.

- Bus stops with shelters
- High bicycle and pedestrian activity
- Sidewalk gaps
- Pedestrians crossing mid-block across railroad
- Short pedestrian crossing time at Vineyard Avenue & Riverpark Boulevard intersection
- Limited landscaping and few shade trees

- Upgrade existing crosswalks with high-visibility striping
- Fill sidewalk gaps
- Explore adding mid-block pedestrian crossing opportunities
- Explore adding curb extensions at crosswalks to shorten pedestrian crossing distances
- Lengthen pedestrian crossing times at Oxnard Boulevard & Vineyard Avenue and Vineyard Avenue & Riverpark Boulevard
- Upgrade curb ramps

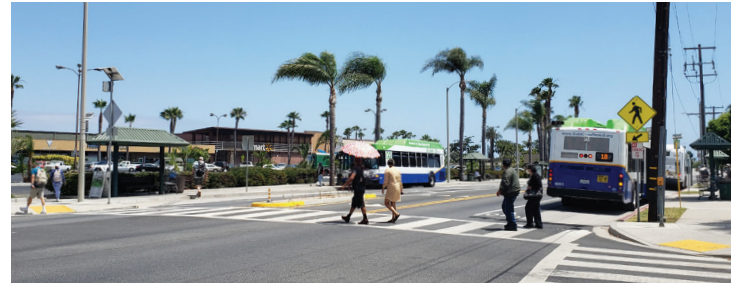
High pedestrian activity around transit stops at Centerpoint Mall.

- Real time transit information at bus stops
- High bicycle and pedestrian activity
- Flashing beacons for crosswalks with high pedestrian activity
- Bike lanes along corridor
- Sidewalk gaps
- Obstructions, such as utility poles and signage, along sidewalk
- Segments with narrow sidewalks
- Many people with additional mobility needs near Centerpoint Mall

| <ul style="list-style-type: none"> • Upgrade existing crosswalks with high-visibility striping • Increase sidewalk widths • Explore adding curb extensions at crosswalks to shorten pedestrian crossing distances • Lengthen pedestrian crossing times at C Street & Channel Islands Boulevard | <ul style="list-style-type: none"> • Extend bike lane facilities • Install green conflict striping at intersections and driveways • Install bike racks around commercial areas and bus stops | <ul style="list-style-type: none"> • Install bus shelters and benches at transit stops • Consider lowering speed limit to 25 mph to improve bike and pedestrian safety |

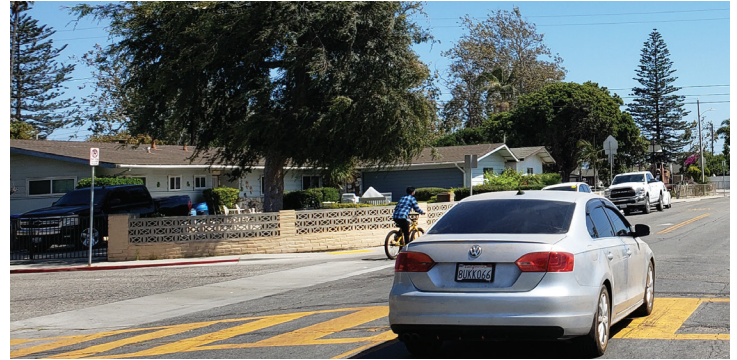
Opportunity for traffic calming so bicyclists feel comfortable biking on road.

- High pedestrian activity around neighborhood commercial
- High visibility crosswalks near school and transit stops
- Narrow sidewalks
- Obstructions, such as utility poles and signage, along sidewalk
- Limited street lighting

- Add advance stop bars and explore adding protected left turns at Channel Islands Boulevard & Gisler Avenue
- Add traffic calming elements, such as speed humps or mini-roundabouts

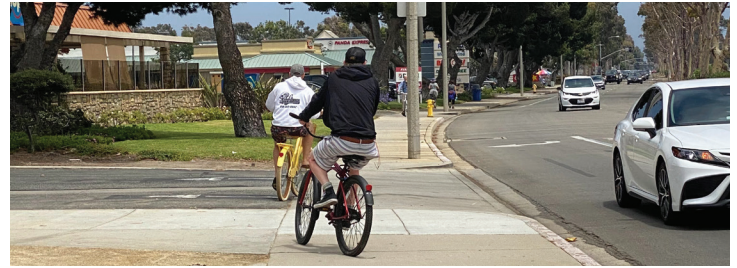
Many cyclists using sidewalk.

- High bicycle and pedestrian activity
- Good tree coverage on Channel Islands Boulevard, east of Victoria Avenue, near bus stop
- Sidewalk gaps
- Short pedestrian crossing times
- Degraded wayfinding signage
- Gaps in bicycle facilities

<ul style="list-style-type: none"> • Explore designs for a protected intersection • Upgrade existing crosswalks with high-visibility striping • Upgrade curb ramps • Lengthen pedestrian crossing times • Upgrade and add wayfinding signage 	  <ul style="list-style-type: none"> • Explore designs for a protected intersection • Install green conflict striping at intersections and driveways • Stripe buffer for bike lanes on all approaches • Improve bicycle facility for cyclists traveling southbound on Victoria Avenue towards the intersection of Channel Islands Boulevard & Victoria Avenue • Explore coordination with property owner(s) to pilot or install a micro-mobility hub (e.g., bikeshare/scootershare parking) near the transit stop 	  <ul style="list-style-type: none"> • Install bus shelters and benches at transit stops • Install advance stop bars at each intersection approach • Narrow travel lanes and reallocate space to enhance bike lanes

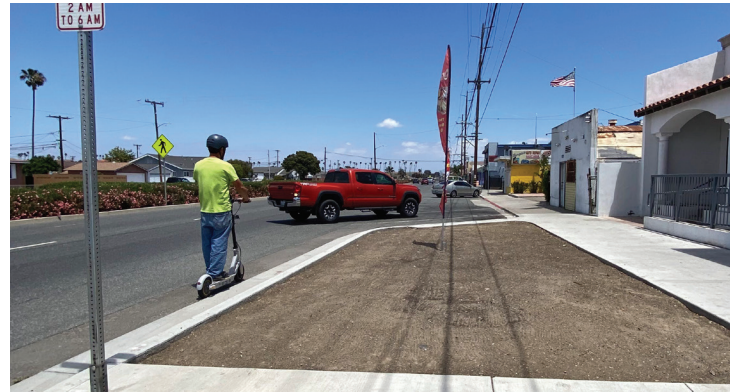
Opportunity for greening and trees along sidewalk.

- Many people walking and bicycling around residential neighborhoods
- Narrow sidewalks
- Obstructions, such as utility poles and signage, along sidewalk
- Limited pedestrian crossing opportunities due to railroad in median

<ul style="list-style-type: none"> • Upgrade existing crosswalks with high-visibility striping to encourage crossing at designated crosswalks • Increase sidewalk widths east of Wooley Road & Ventura Road • Explore adding pedestrian crossing opportunities to encourage crossing at designated crosswalks • Explore adding curb extensions at crosswalks to shorten pedestrian crossing distances 	<ul style="list-style-type: none"> • Stripe buffer for bike lanes • Add bike racks at commercial areas 	<ul style="list-style-type: none"> • Coordinate with Gold Coast Transit District to upgrade bus stops with seating and shade • Narrow travel lanes and reallocate space to enhance bike lanes
		<ul style="list-style-type: none"> • Add vegetation along south side of Wooley Road for cooling • Explore opportunities to create a more permeable and/or cooler surface
